# Safety on Site

DUFFY GROUP LTD

July 2009

## SAFETY ALERT-LIFTING WITH BEAM CLAMPS

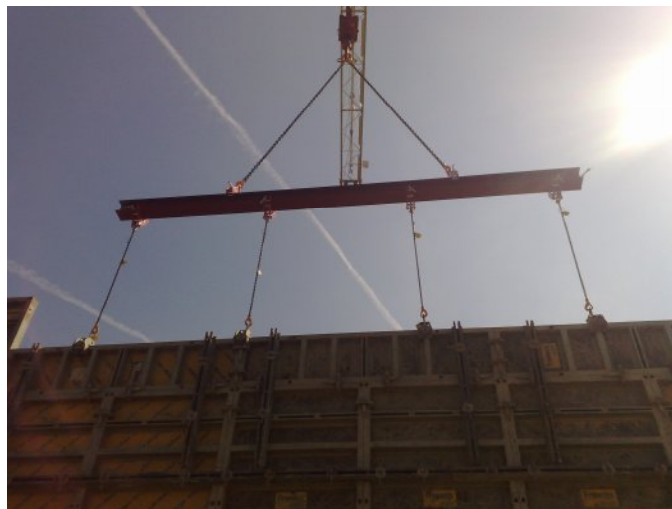
A lift of a section of system formwork was being undertaken. The method of lifting the formwork was using a steel lifting beam (I-beam) with 2 beam clamps on the top side of the beam with chains to the crane, and 4 beam clamps connected to the underside of the beam with chains connected to the DOKA frame. The photo to the right shows an example of a lift of this type on the site.

When the shutter was approximately 1.5m off the ground one of the upper clamps failed and slid down the beam until it reached the second clamp, the beam went from horizontal to vertical and the shutter consequently fell to the ground. No one was injured.

selected to fabricate the lifting beam, recommended the beam clamp system as shown above. When a deviation from an agreed method takes place, the risks of something going wrong are hugely increased, especially if the deviation is not subjected to the same checks and controls as the original method.

In this case, these beam clamps should not have been used in this manner. Beam clamps of this type have been designed for

lifting on a vertical axis only. No oblique loading should take place unless the clamps being used are designed for this purpose.

The original design has now been adhered to which incorporates a lifting method where any risk of movement of lifting accessories is minimized as far as reasonably practicable. This lifting beam (see photo below left) has six lifting eyes welded on to the beam - two at the top and four at the bottom. These welds have been fully tested, and the unit as a whole has been fully tested before it was put to use.

Any lifting operation must be fully planned and any design incorporated into the lifting configuration must include worked calculations showing the WLL of the lifting apparatus. All accessories must be used in the manner they were designed for. If you are in any doubt, contact the manufacturer or the Safety Department.
