# Safety on Site

DUFFY GROUP LTD

March 2009

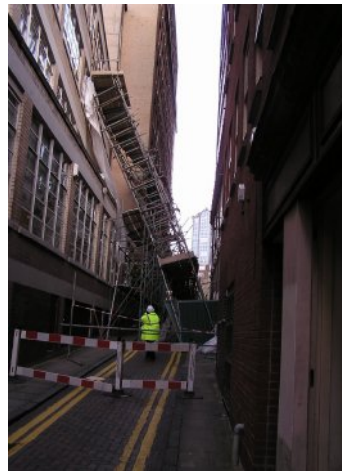
On 13th December 2006 scaffolding, measuring between up to 50ft high and spanning 100ft along the side of a building, collapsed across Needles Alley at 6.40pm as it was being used by pedestrians.

HSE Inspector Mike Ford said: "The incident placed pedestrians and workers at risk because the two companies had failed to provide a scaffold that was suitably tied to the building and failed to ensure that the scaffold was inspected regularly after the erection.

"All employers have a responsibility to ensure that safe working practices are in place, because failure to do so could well cost lives, as well as enforcement action from HSE. It is extremely fortunate that nobody was injured, as CCTV footage of pedestrians passing within seconds of the collapse clearly demonstrates, it could have been so much worse."

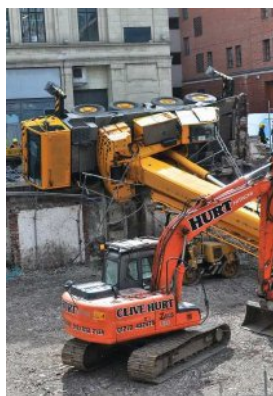
A mobile telescopic crane has overturned on a new hotel project in the centre of Manchester. The crane operator avoided serious injury as the crane jib came to rest in the nearby River Medlock.

The photograph shows that outriggers on one side of the crane are extended. The position of the crane suggests outriggers on the opposite

side would have been in close proximity to the edge of an excavation. Most mobile crane overturns are due to loading on outriggers exceeding the ground bearing capacity. Lifting plans should always explicitly address this issue.
